# Heritage Conservation Collective

## *Cemetery Conservation and Preservation Plan African Union Church of South Coventry Pottstown, PA*

Prepared For:  
Friends of the African Union Church of South Coventry

September 2023

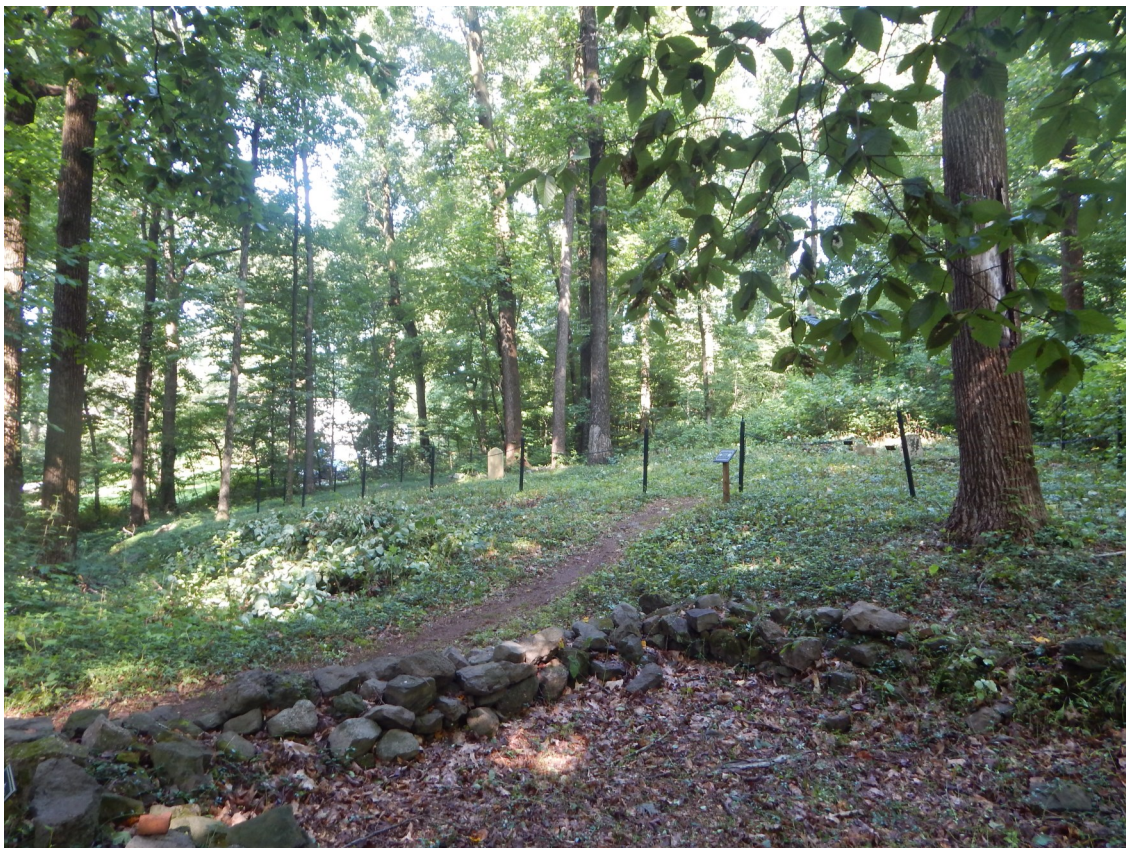
Overview of the cemetery, July 2023. Church building foundation visible in the foreground.

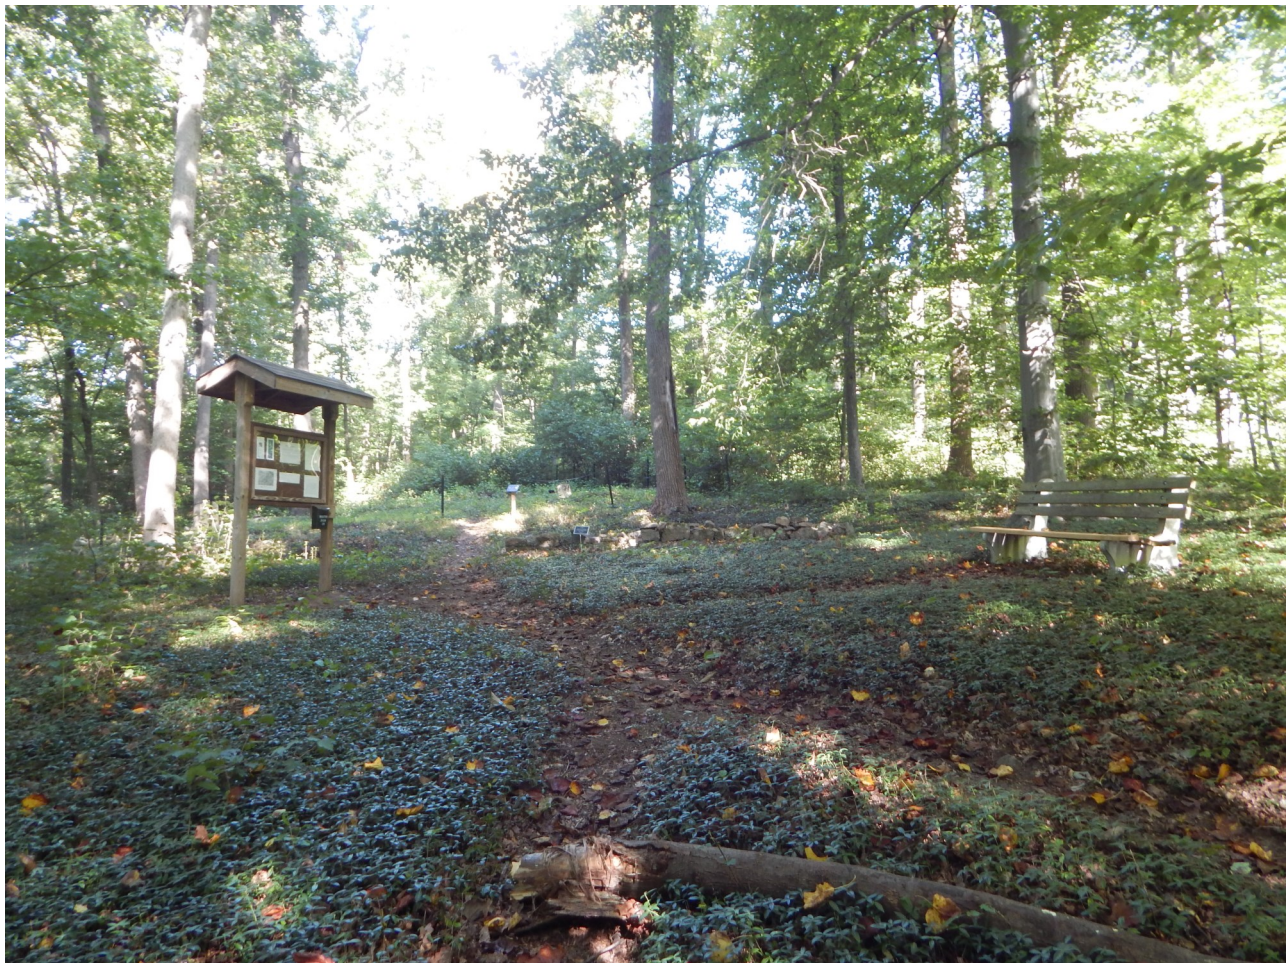
Overview of the property looking towards the burial ground. Kiosk is on the left, bench on the right, church foundation is visible just beyond the kiosk and the bench, the burial ground fence is visible in the background, August 2023.

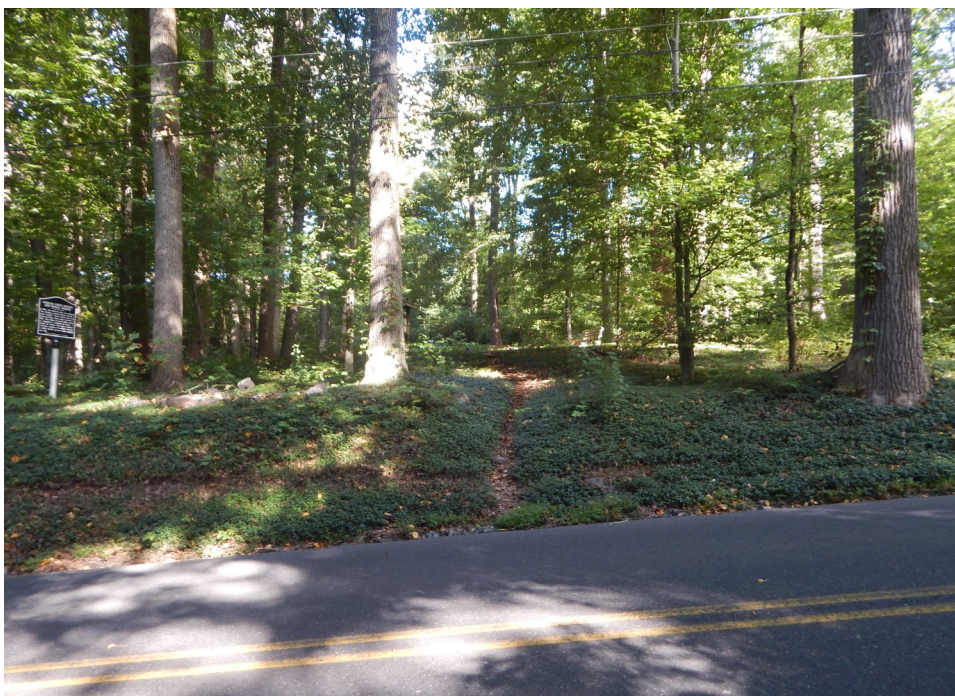
View of the site from the parking area along Coventryville Road, August 2023. The presumed original path to the site is in the center of the photo. The path currently used most often to access the site is just out of the photo frame to the right of the large tree on the righthand edge of the photo.

Access to the site can be improved. Widening the footpath will provide safer and easier access to the site and also make it more visible from Coventryville Road. Next steps include excavating what is believed to be the original entranceway to determine if additional stone steps still exist. It would be ideal to restore to the extent possible the historic entrance. FAUCSC should also determine which path (front or side) will be maintained as the primary entrance and develop a plan to clear it, widen it slightly, and maintain it. It may be best to keep both paths cleared—one to denote the historic entrance and the other to provide modern day access. Volunteers can complete this task but landscapers could also be hired if needed.

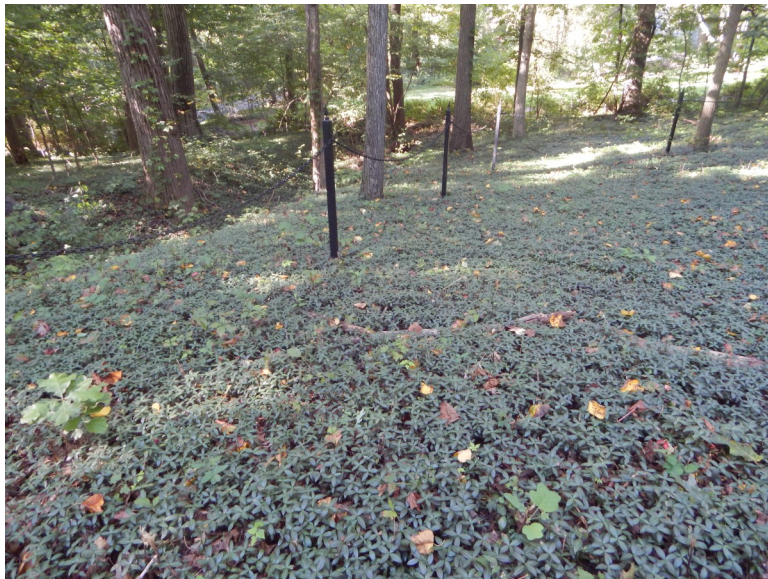
Vinca blankets not only the burial ground area but much of the site all the way to the entrance on Coventryville Road, August 2023. Saplings, vines and other invasive species also grow here making it a challenge to keep it continually maintained. Vinca itself is not a native species and the spread of it also tends to be hard to control; however, removing the vinca in favor of a native species is not a viable option. Perhaps containing it to the approximate borders of the property would be helpful.

As described in the report, the site is in a wooded area with mature trees and heavy vegetation. The appearance of the area when it was in active use is not documented leaving us with the remains of the church building foundation and the grave markers as a guide. The naturalness of the site should be preserved and trying to create a formal cemetery is not advised. Unfortunately, there is no easy solution to the maintenance of the vegetation that is required to keep the site from being overgrown. As mentioned previously, vinca is not a native plant in this area but has some significance to this site and is a priority to retain. Pulling saplings and other weeds by the roots to prevent regrowth rather than trimming alone will help over time to reduce maintenance. Sprays for weeds will only damage the vinca so keeping weeds down in this way is not an option. Establishing the boundaries that are desired for maintenance is helpful so that not all areas need to be maintained to the same degree. For instance keeping the paths clear and weeding within the burial ground fence. FAUCSC has been successful in holding two workdays a year (spring and fall) and this should continue. The clearing and weeding of the site can continue to be maintained by volunteers if there is enough manpower; although occasionally hiring landscapers to help with the more difficult removal of hardier weeds and saplings may be desired as funding allows.

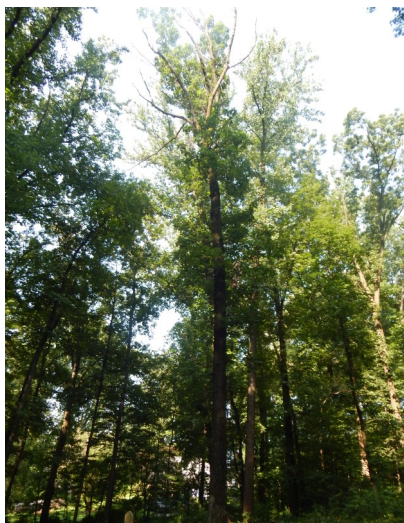
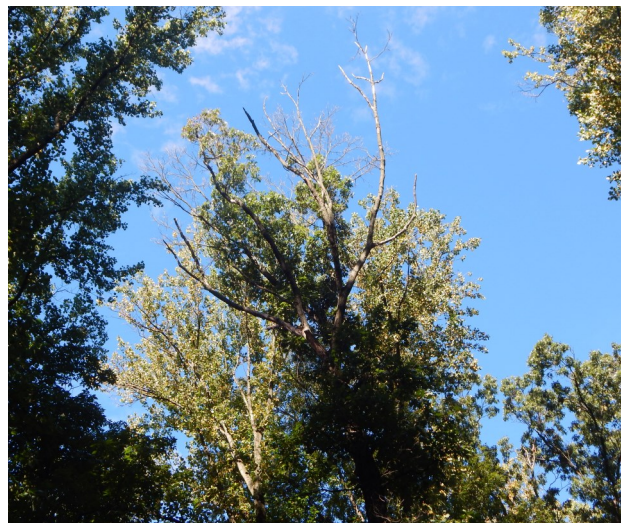
The burial ground gets overgrown easily and there are many mature trees on the property. Within the burial ground itself there is one mature tree with several dead branches that is a hazard to the site and another tree just outside the fence that will likely also be removed due to decay.

A mature tree (overall photo left and detail of top right) within the burial ground boundaries that has a significant amount of dead branches, July 2023. As these branches fall they present a danger to the remaining grave markers.

Two mature trees identified by FAUCSC are slated for removal as funds allow. One is within the burial ground boundaries and has large dead branches in the upper portion of the tree that are an immediate danger to the grave markers as they break and fall. There is a second tree just outside the burial ground near the church foundation that is damaged and also slated for removal. The tree work will need to be undertaken by a professional tree removal company.

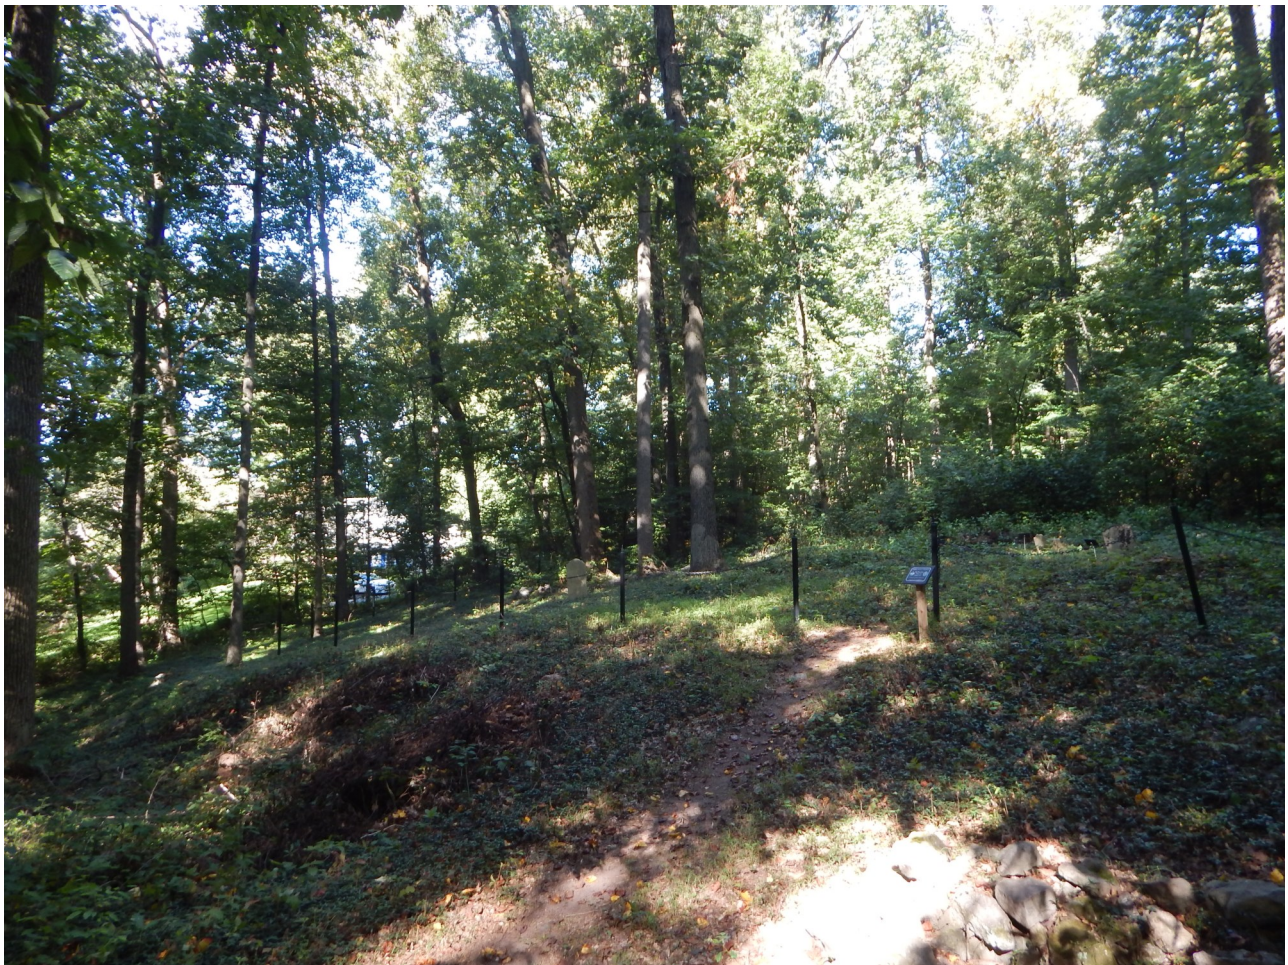
The three extant carved marble markers date to 1853, 1874, and 1882 and remain in overall fair to good condition. General conditions present including heavy soiling of biological growth, misalignment (tilted or leaning), disaggregation, and one marker has a fragment missing. In addition to the marble markers there are approximately ten identified fieldstone markers. While these markers do not exhibit any visible carvings, they are set in an upright position indicating that they were purposefully set, and GPR also confirmed a disturbance in these areas further confirming they mark burials. There were active stone quarries in Chester and other surrounding counties throughout the 1800s which are a likely source for the stone used for the marble markers. The fieldstone native to the area is a sandstone conglomerate. The conglomerate consists of a sedimentary rock with rounded pebbles that are greater than 0.08 inches in diameter. It has an appearance somewhat like concrete, with pebbles cemented together by finer grained material. This is noticeable especially in the stones used to form the remains of a wall along the rear portion of the burial ground. A map showing the stone types in this county as well as photos of the conglomerate can be found on page 11.

Overview of the burial ground from the church building foundation. July 2023.

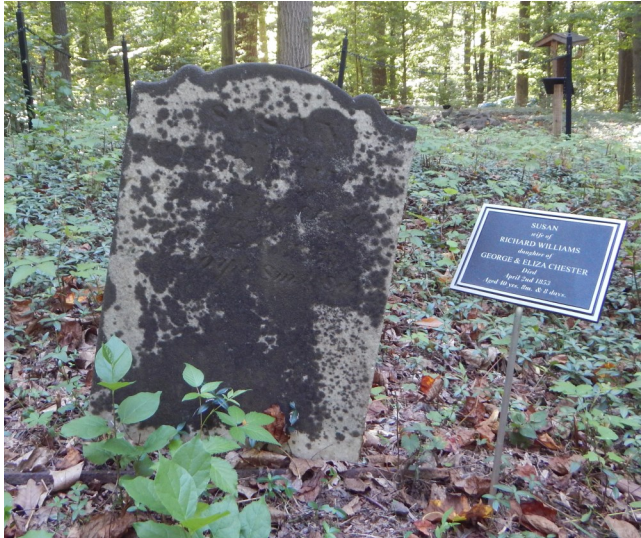
Susan Williams grave marker condition, July 2023.

This marble headstone is heavily soiled by biological growth and leaning to one side. There is slight disaggregation of the stone present. Excavate, straighten, and reset. Clean to remove biological growth. Clear invasive vegetation. Consolidation to arrest disaggregation can be considered. Evaluate after cleaning.

Straighten and clean the two remaining marble markers . Volunteers can accomplish this task using the same technique that was employed to reset the Emma J. Johnson marker. Once the markers have been cleaned and reset, a stone consolidant can be applied to the surface of the two markers showing signs of disaggregation (Susan Williams and John Thomas) which would help slow the deterioration of the surface of the stone. A properly selected and applied stone consolidant still allows for the surface of the stone to be breathable, and it does not seal or trap moisture. An architectural conservator should be engaged to select and apply the consolidant. In addition, the area around the John Thomas marker can be carefully probed by a volunteer to see if the fragment may be on site just below the soil surface. If located, an architectural conservator should be retained to reattach the fragment.

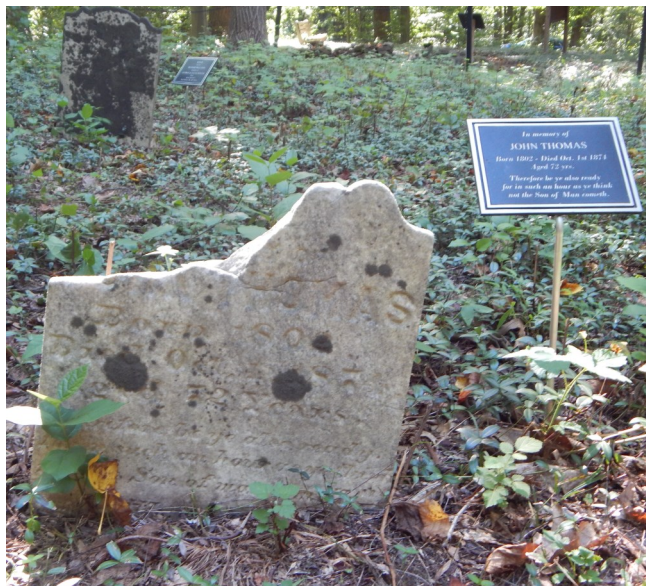
John Thomas grave marker condition, July 2023.

This marble headstone is lightly soiled by biological growth and leaning to one side. There is slight disaggregation of the stone present. The upper left portion of the headstone is missing. Gently probe surrounding area to ensure fragment is not nearby. Excavate, straighten, and reset the marker. Clean to remove biological growth and clear invasive vegetation. Consolidation to arrest disaggregation can be considered. Evaluate after cleaning.

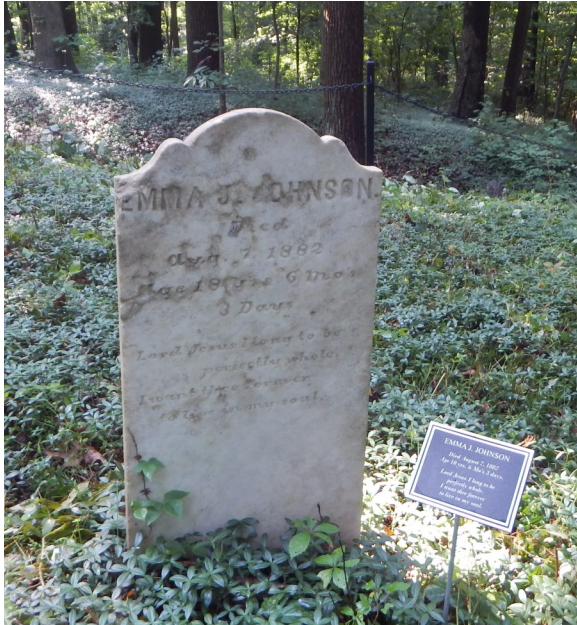
Emma Johnson grave marker condition, July 2023.

This marble headstone has already been reset and cleaned by FAUCSC. It needs no further treatment at this time. Keep clear of invasive vegetation including climbing vines.

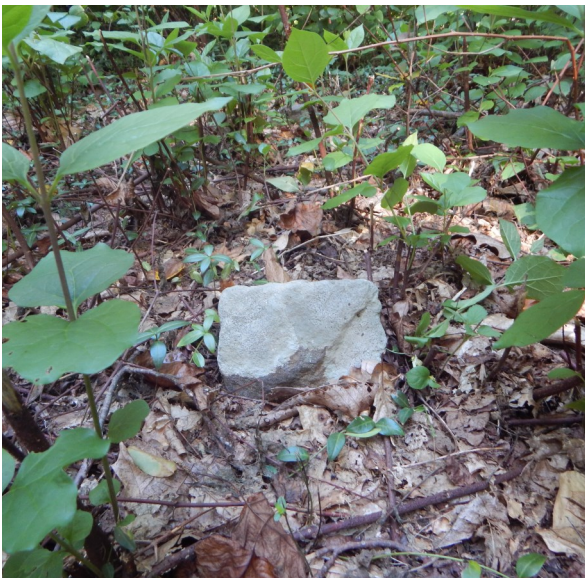
Typical conditions present, July 2023.

There are approximately ten fieldstones identified as grave markers in the burial ground. While none appear to be carved, they are set in an upright manner indicating that they are purposefully set and mark graves. Like the marble markers, some of these are lightly soiled by biological growth but generally remain in good condition.

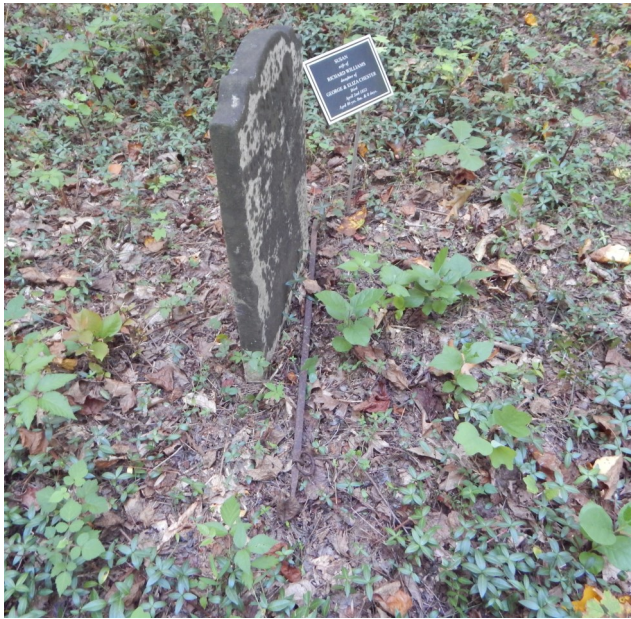
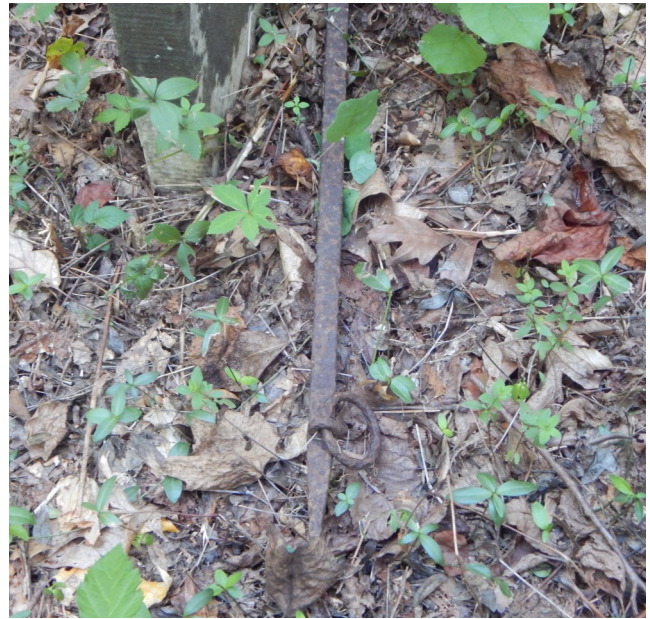
There is manmade metal component laying with the Susan Williams marker (photo taken July 2023). This may have been part of a plot fence surrounding her grave or from some other part of the cemetery. While it is understandable to leave it where it was found, after documenting it through photography it would be best to store it securely off site.

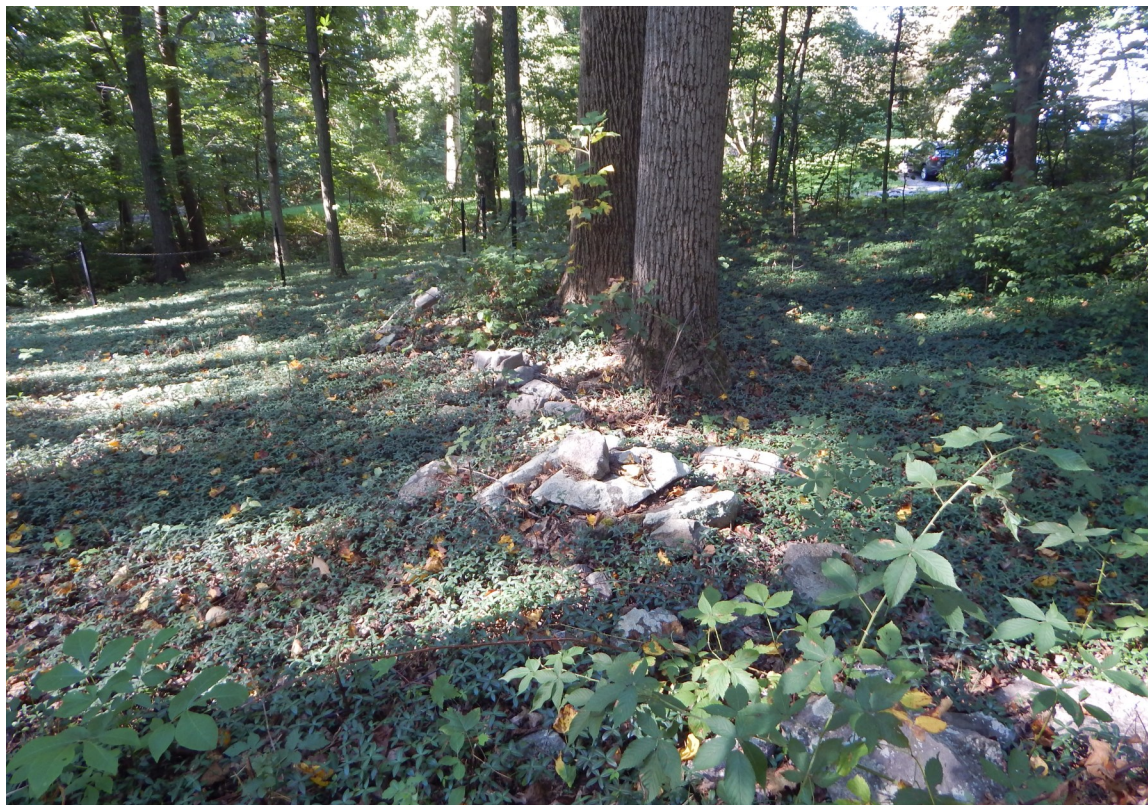
Remnants of the fieldstone wall along the rear of the burial ground, August 2023.

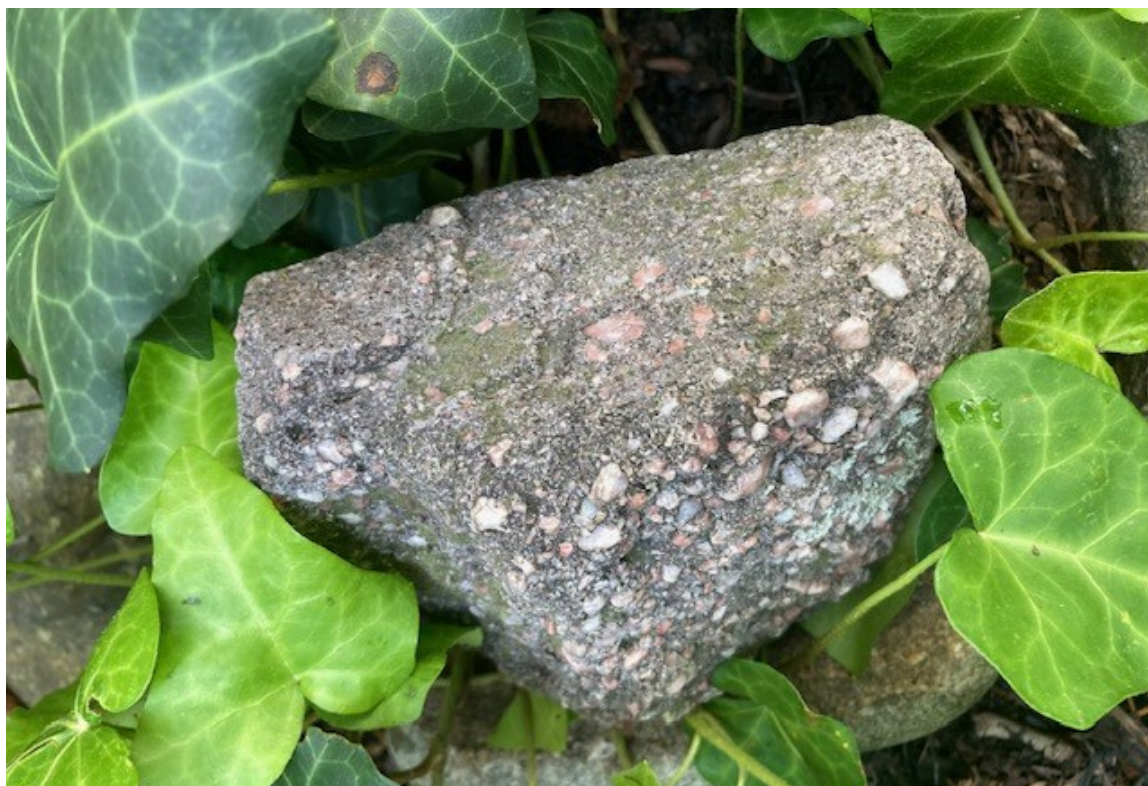
Detail of sandstone conglomerate common in this area, August 2023.
